# **PRIEDAI**

## VILNIAUS AUKŠTUTINĖS PILIES VERTIKALIŲ DEFORMACIJŲ TYRIMAI

## Research of Vilnius Upper Castle vertical deformations

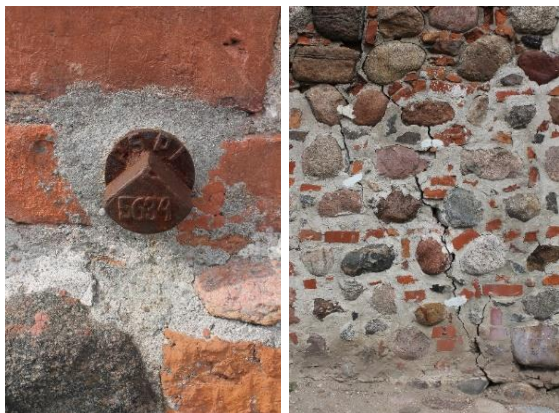
Apžiūrėjus vietovę buvo rastos išlikusios 36 markės. Viena iš jų, esanti ant Gedimino Pilies pavaizduota 10 pav. Statinių sienose matomi plyšiai tik patvirtina jog vyksta statinių deformacijos (10 pav.).

**10 pav.** Kairėje markė Nr. 5634; dešinėje Kunigaikščių rūmuose esantis plyšys

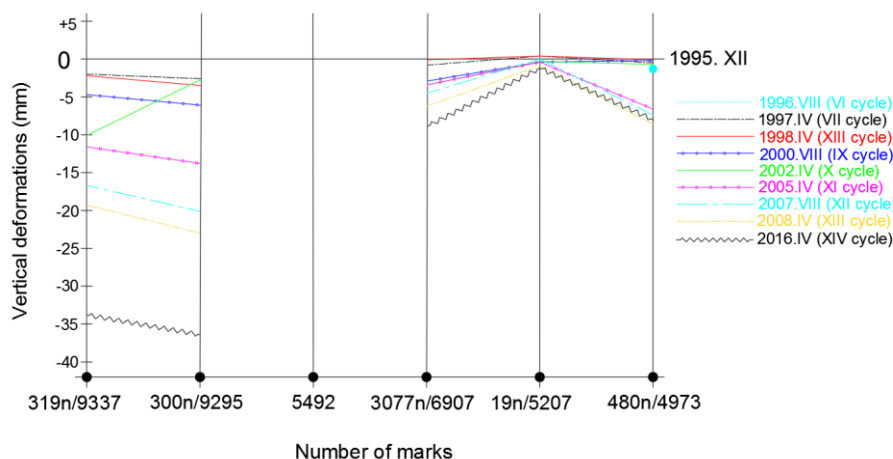
years since December 1995 the biggest average vertical deformation was detected on Southern Retaining Wall (21.8 mm) and the lowest – at Northern Wall (5.1 mm). Southern Retaining Wall's mark Num. 9455 vertical deformation during data of measurements was the biggest – 41.0 mm and the East Retaining Wall's mark Num. 19n/5207 contrariwise – 0.9 mm.

Fig. 4 Vertical deformations of Southern Retaining Wall.

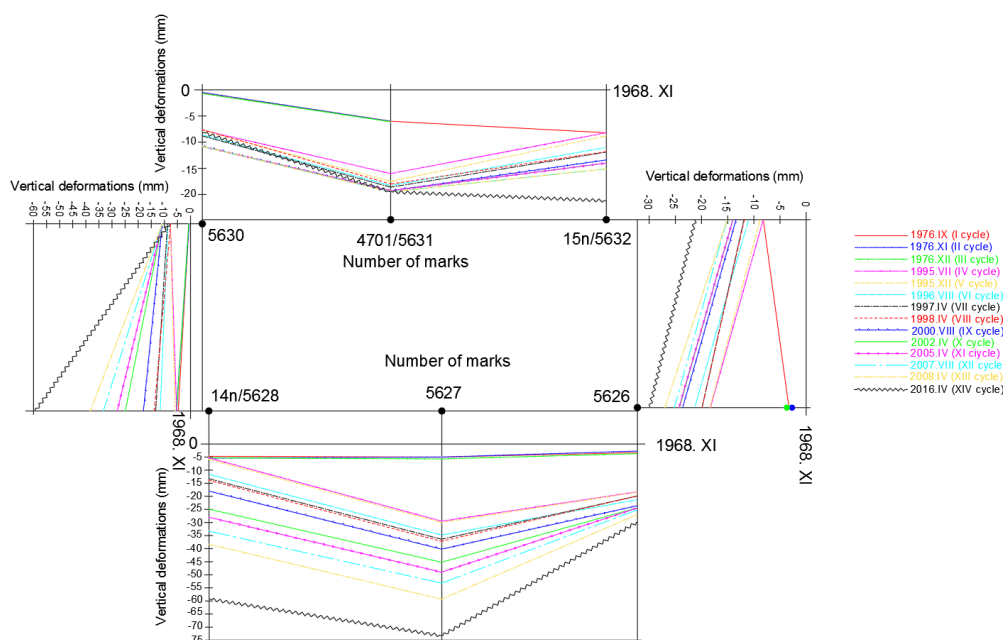
Comparing all data (from November 1968) with the data of the last cycle in 2016 (48-years period), most average vertical deformations were established at Grand Duke Palace (35.2 mm), Gediminas Tower and a part of Southwestern Defensive Wall (28.7 mm). Foundation of the Southern Tower has not been recorded due to the corrosion of marks. The biggest vertical deformation during period since 1968 was observed at Grand Duke's Palace mark Num. 5627 (73.3 mm); the lowest 8.1 mm of mark Num. 5630. Since December 1995 (21-years period) the biggest average vertical deformation was detected on Southern Retaining Wall (26.4 mm), the lowest – 10.6 mm of Southwestern Defensive Wall (near Gediminas Tower), the vertical deformation of East Defensive Wall on average was 17.7 mm. South Defensive Wall's vertical deformation value (48.7 mm) was established of the mark Num. 9270; the lowest - of the mark Num. 19n/5207 (East Defensive Wall) – 1.2 mm.

Fig. 7. Vertical deformations of Grand Duke Palace.

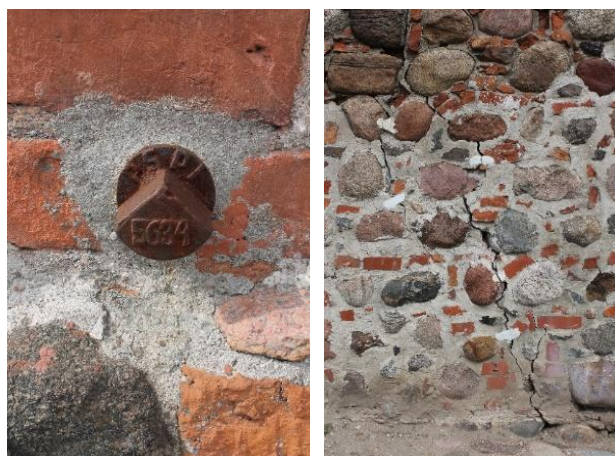
The whole area was inspected carefully and 26 marks have been found around the Upper Castle. One of the Gediminas Castle marks is shown in figure 8. Visible cracks in the structures (figure 8, on the right) confirm about permanent deformations.

Fig. 8. Mark Num. 5634 on the left; on the right – visible crack on Grand Duke Palace.

5. In order to avoid vertical deformations, it is necessary to extend geodetic monitoring, especially in problem areas and carry out reinforcement works. Gediminas Hill is worthy to be monitored by specialists as it is Lithuanian statehood and became the symbol of the cultural heritage of the country's capital, which is the most important dominant object throughout the history of Vilnius city.

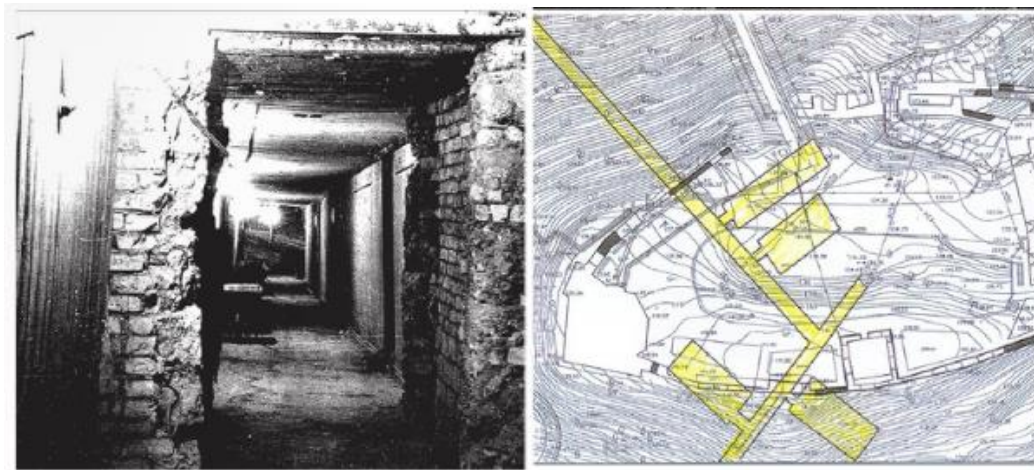
Steep slopes, plants, rotting stumps are causing erosion and landslides of the slopes. Several large landslides were mentioned in technical reports (a new landslide was recorded at the end of 2016), which probably influenced vertical deformations of the Vilnius Upper Hill structures. Poor draining, improperly performed works of slope stabilization, trample down vegetation areas, existing underground structures (tunnels and shafts). In the article of “STRUCTUM” magazine (Lekaviciene, 2014), it was offered to analyse all previously collected information of Vilnius Upper Castle conditions when the threat has occurred. The article also reveals one of the secrets of Gediminas Hill – underground tunnels: mysteriously winding underground corridors entering premises, brick or wood lumber walls, in some places ceilings have wooden supports. Scheme of the tunnels and photos are shown in Figure 9. According to the head of the Public Enterprise “Lietuvos paminklai“ V. Drumsta, underground tunnels were dug by prisoners of war during WW II. Condition of these tunnels is not investigated yet, but the fact is that effect exists. It is because of bad conditions of the overall underground structures. While searching for causes of failures and landslides of the hill, scientists raised hypothesis that the main issue is poor conditions of underground structures and failure of constructions (Lekaviciene, 2014).

Fig. 9. Underground tunnels of Gediminas Hill (Lekaviciene, 2014).
