# **PRIEDAI**

## VILNIAUS AUKŠTUTINĖS PILIES VERTIKALIŲ DEFORMACIJŲ TYRIMAI

## Research of Vilnius Upper Castle vertical deformations

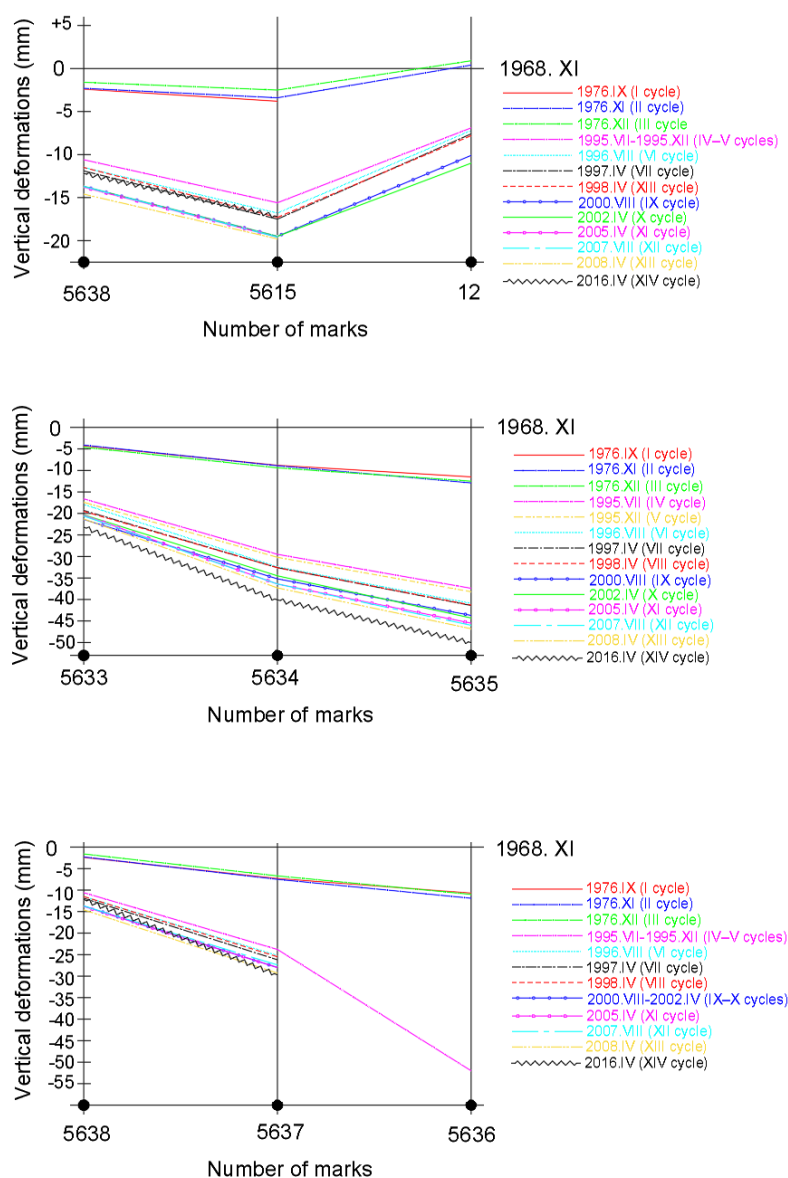
Fig. 5. Vertical deformations of Gedinimas Tower and a part of Southwestern Defensive Wall.

Comparing all data (from November 1968) with the data of the last cycle in 2016 (48-years period), most average vertical deformations were established at Grand Duke Palace (35.2 mm), Gediminas Tower and a part of Southwestern Defensive Wall (28.7 mm). Foundation of the Southern Tower has not been recorded due to the corrosion of marks. The biggest vertical deformation during period since 1968 was observed at Grand Duke's Palace mark Num. 5627 (73.3 mm); the lowest 8.1 mm of mark Num. 5630. Since December 1995 (21-years period) the biggest average vertical deformation was detected on Southern Retaining Wall (26.4 mm), the lowest – 10.6 mm of Southwestern Defensive Wall (near Gediminas Tower), the vertical deformation of East Defensive Wall on average was 17.7 mm. South Defensive Wall's vertical deformation value (48.7 mm) was established of the mark Num. 9270; the lowest - of the mark Num. 19n/5207 (East Defensive Wall) – 1.2 mm.
